## Welding procedures of Turbine Blades by Using ER 309L Austenitic Filler Wire

**Abstract**-In the present work it has been investigated the repair of LP-blades steam turbine made of AISI 410 martensitic stainless steels (MSS) by GTAW welding, the repair welding carried out by using ER 309L as consumable filler wire. PWHT was carried out at 1100°C for 1h. The structure-property relationships of the weldments were established based on the current modes employed by utilizing combined techniques of optical microscopy, line/point and EDS analysis. Results showed that Micro-hardness along the base and HAZ regions increased after PWHT as compared to in state of as-welded. After welding process, microstructure photographs of weld-metal region revealed two phase the vermicular  $\delta$ -Ferrite and  $\gamma$ -austenite matrix. HAZ region consisted of tempered lath martensite with carbides. Line/Point analysis revealed the direction of segregation, whereas chromium was increased in core and depleted in boundary, while nickel was depleted in core and increased in boundary, this support the  $\delta$ - ferrite was primarily solidified.

How to cite this article: A.H. Fadhil, S.A. Emad, K.H

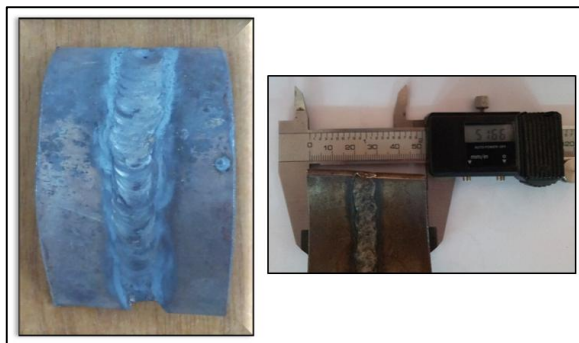
**Figure 1: Specimen after welding**

(25mm\*100mm). Followed by, it is achieved standard V-Butt configurations (single V-groove having a root face of 2 mm, size land of 1 mm and included angle of 70°) was worked on these pair's. Multi-pass welding was performed through TIG welding machine (type/ ESAB LRT 160, Materials Engineering, University of technology) and V-butt welding joint process was depended on the skill of welder; Figure 1, illustrated specimens after welding. No preheating was made before welding to a void hydrogen induced cracks. The parameters of welding joint were fixed: - Main Supply 70-80 V/Hz, Current Range 130 A and Gas Flow Rate 6 L/min-1. When welding process was completed, the samples were cute by Wire Electrical Discharge Machining (WEM) or Wire-Cut EDM (type/ Smart DEM), to small specimens with dimension (50 \* 10 \* 10) mm, as shown in Figure 2. After welding and cutting process, each sectioned specimen was subjected to PWHT (Post Weld Heat Treatment) in order to obtained best mechanical properties and some stress relief. PWHT method was conducted at 1100 °C. PWHT was carried out by using furnace (type/Carbolite 1200). The holding time for PWHT was 1hr and cooling rate 30 C°/min. The furnace was switched off and cross-section specimens were placed in to slowly cool to room temperature in order to prevent high-temperature oxidation of the joint.
